IUFMP *News*

A QUARTERLY NEWSLETTER OF THE
IBADAN URBAN FLOOD MANAGEMENT PROJECT (IUFMP)

First Pool of Works: **24 NEW BRIDGES;** ENHANCED CONNECTIVITY, IMPROVED MOBILITY!

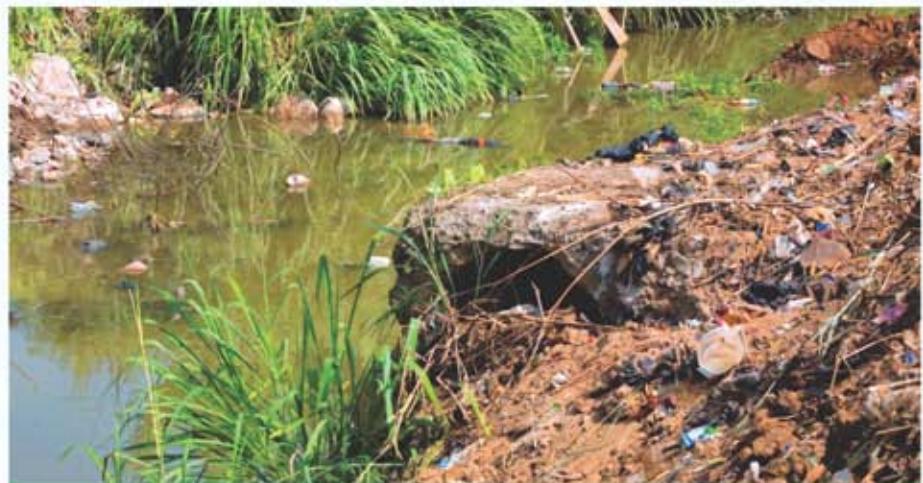
- I. ID No 40:** The existing structure which situates at Francis Okediji Street had earlier been washed away by flood torrents, thus cutting off linkage between that part of Old Bodija and the adjoining communities. The damaged culvert will be replaced with a **2(6.0 x 2.5) m culvert.** ▼

The collapsed Francis Okediji culvert at Old Bodija Area pre-intervention

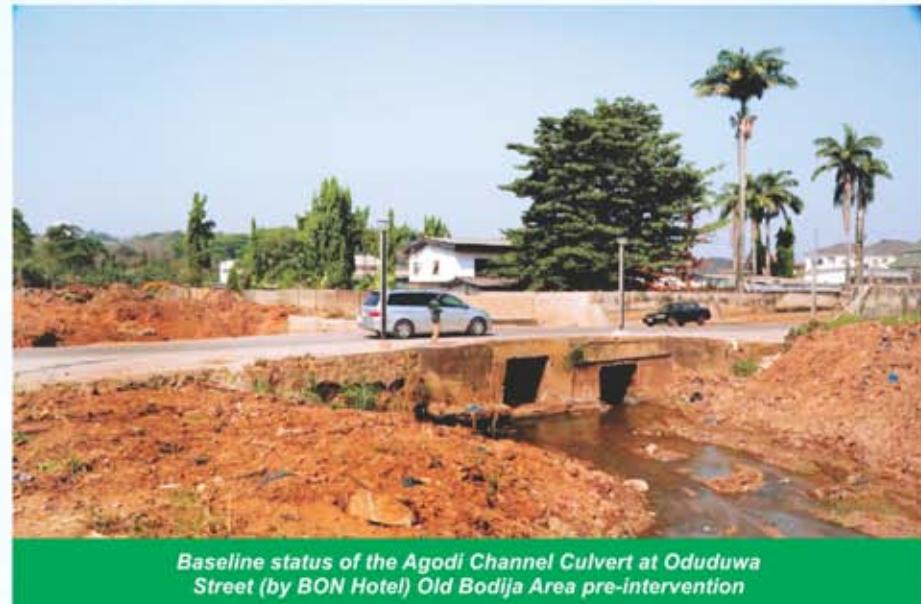
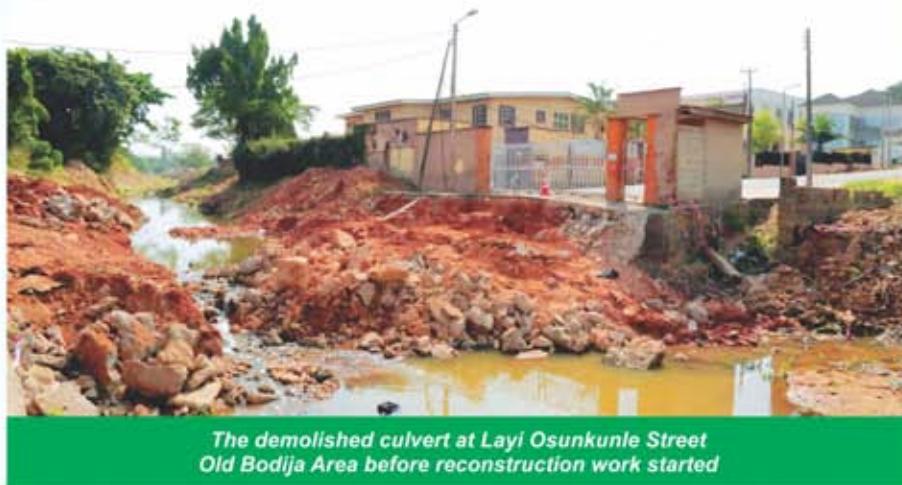
ii. **ID No 41:** This is the tunnel-like structure that channels the Agodi River across Oduduwa Street (by BON Hotel) at Old Bodija. Though the culvert was still standing before construction, the inlet and outlet were evidently too narrow and inadequate for the runoff of the river, thus causing backflow and flooding, especially during periods of heavy downpours. It will be replaced with a **2(6.0 x 2.5) m culvert**.

iii. **ID No 42:** This is the hydraulic device across Agodi River on Layi Osunkunle Street, by Davis Hotel, Old Bodija. Though the structure was still standing before demolition, it had evidently become inadequate for the discharge/volume of runoff, thus causing surrounding houses and vegetation to be flooded. The inadequate structure is to be replaced with a **2(6.0 x 2.5)m culvert**.

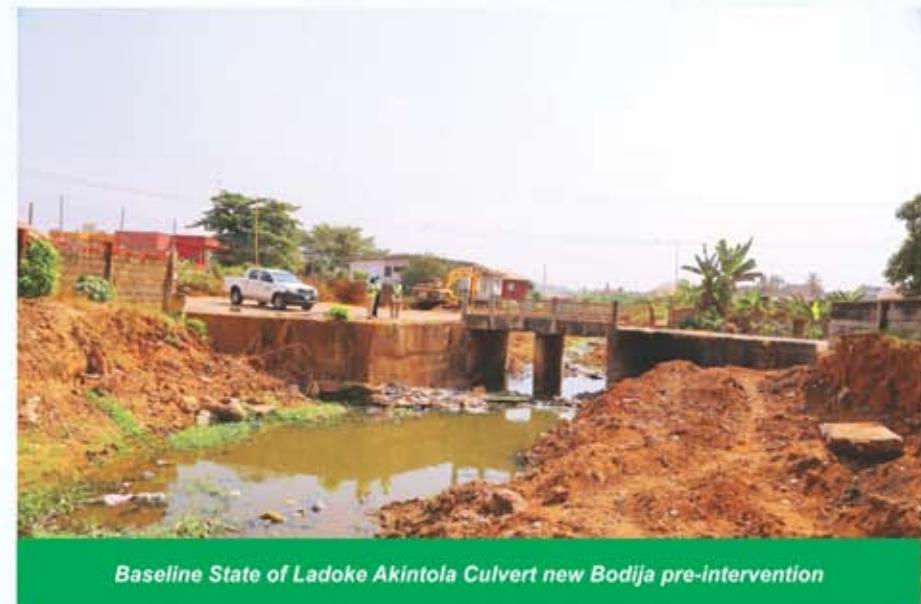
iv. **ID No 627:** This is the culvert that spans the Agodi River at the popular Ladoke Akintola Street, New Bodija. The dimensions of the existing culvert would be too inadequate for the ongoing channelization of the Agodi River, hence the proposed replacement with a **2(4.0 x 2.5)m culvert**.

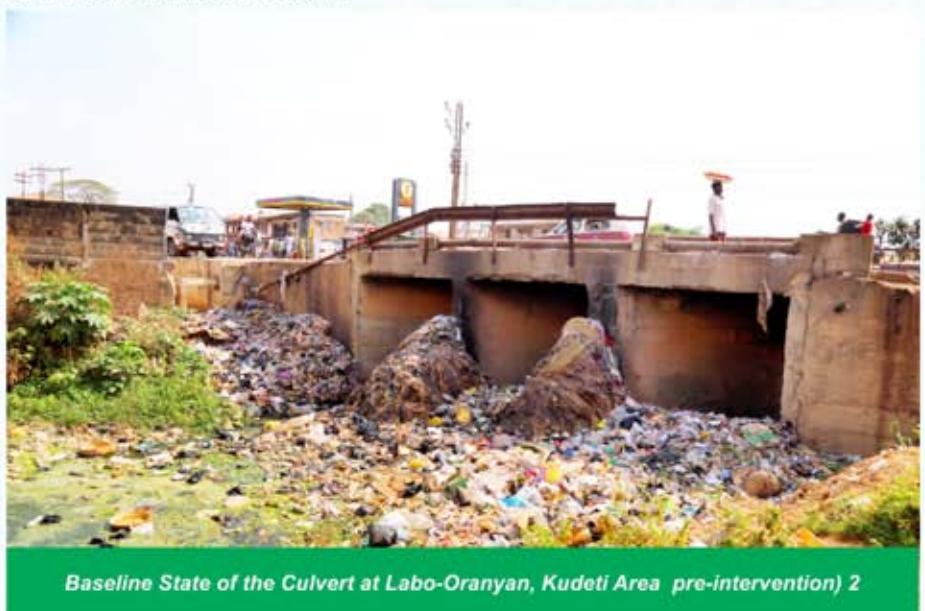
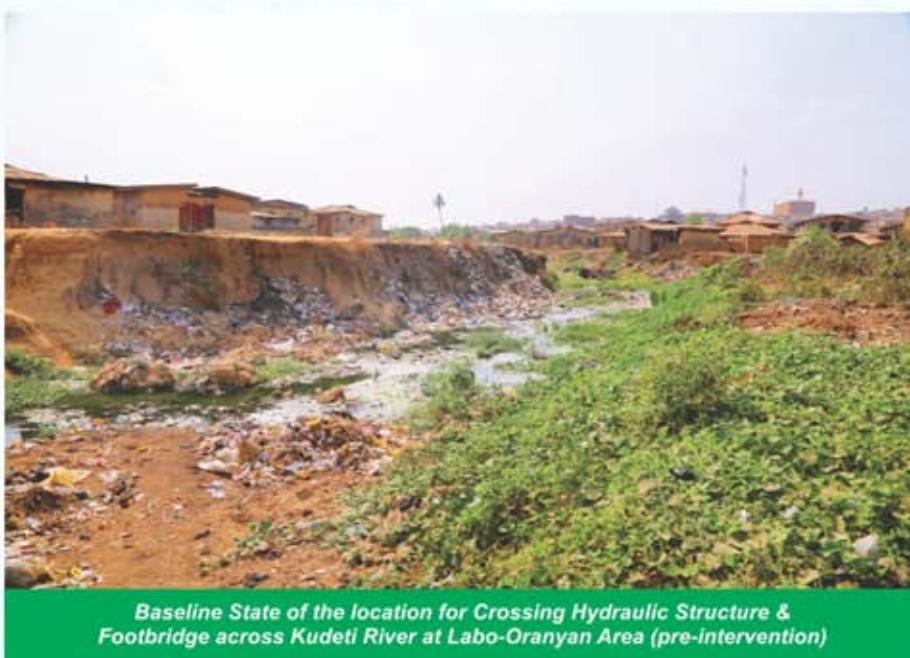
v. **ID No 273:** This structure is to replace the weak, old and degraded culvert across the Labo/Oranyan/Bere Road, by BOVAS Filling Station, which has over the years exposed the area to massive flooding and tragic eventualities. The proposed replacement is an (8.0 x 2.5)m culvert.

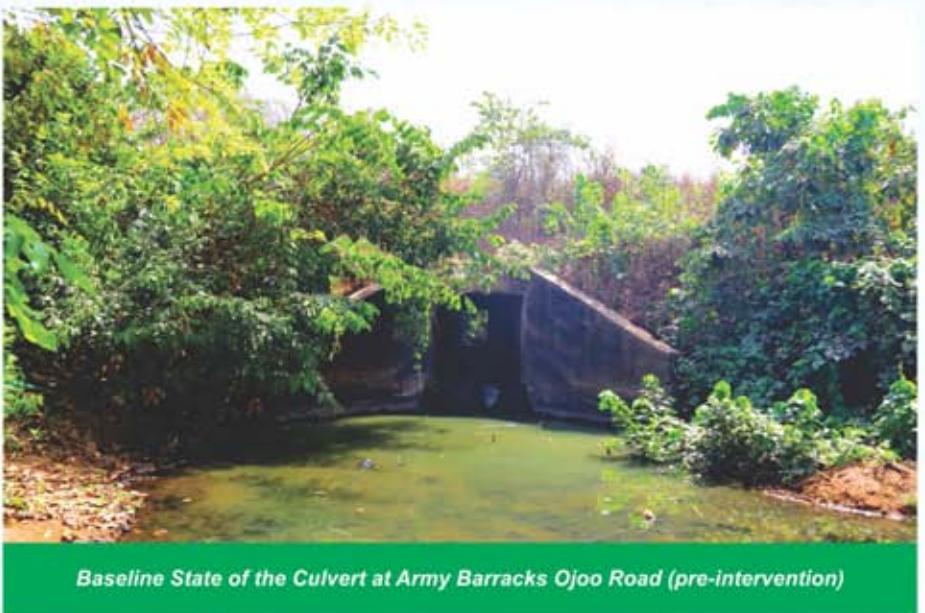
ID No 565: This culvert, located around the Army Barracks off Ojoo Road, has been rendered almost redundant with the road it spans somewhat impassable. A **2(4.0 x 2.0)m culvert** is in the works, as a replacement.

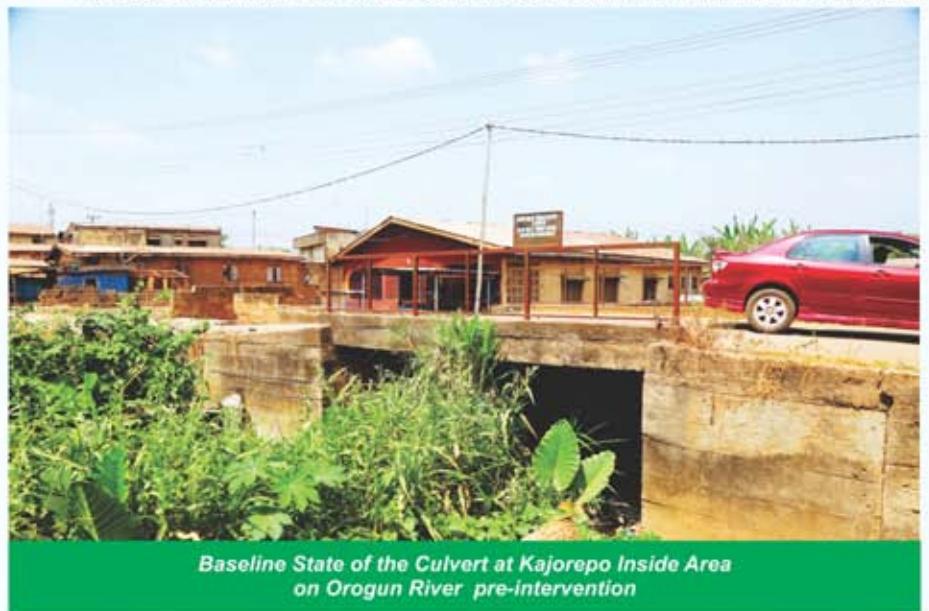
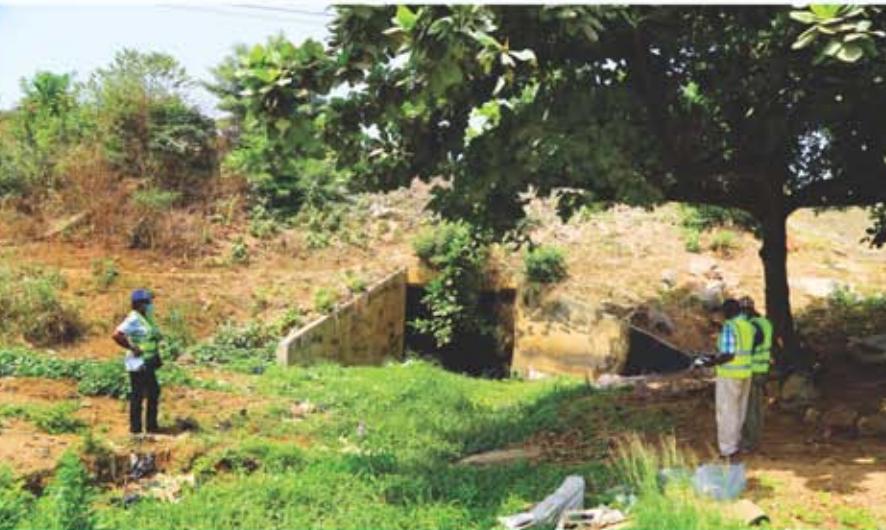
viii. **ID No 678:** This is the access culvert into Kajorepo Community, off Ojoo – Iwo Road. The culvert has become too low and narrow to effectively discharge runoff, thus resulting in overtopping of the culvert and flooding of houses. The culvert is being replaced with a **2(6.0 x 2.0)m** new hydraulic structure.

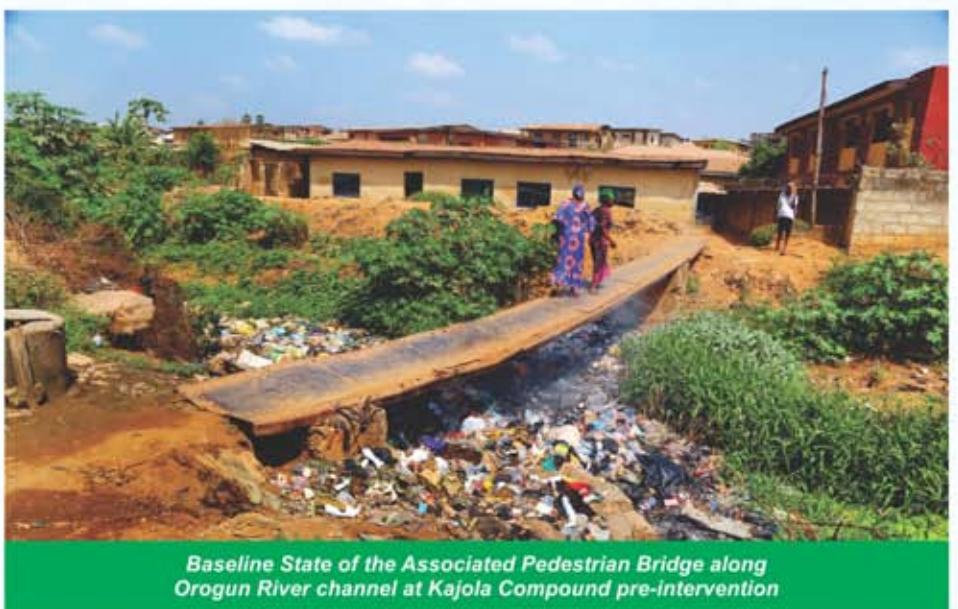
ix. **ID No 677:** This culvert channels the Orogun River from Kajorepo Community across the Iwo Road – Ojoo Expressway. Though the existing hydraulic structure is still structurally adequate, it has become hydraulically inadequate for the volume of runoffs from the downstream of Orogun River. Thus, a **2(6.0 x 2.0)m culvert** is in the works to complement the existing one.

x. **ID No 634:** The Project is executing here an associated crossing structure of **3(5.0 x 2.0)m** over the Orogun River at the Kajola Compound area. Pre-intervention, what existed there was a fabricated metal crossing, which is unstable and insecure for human movement.

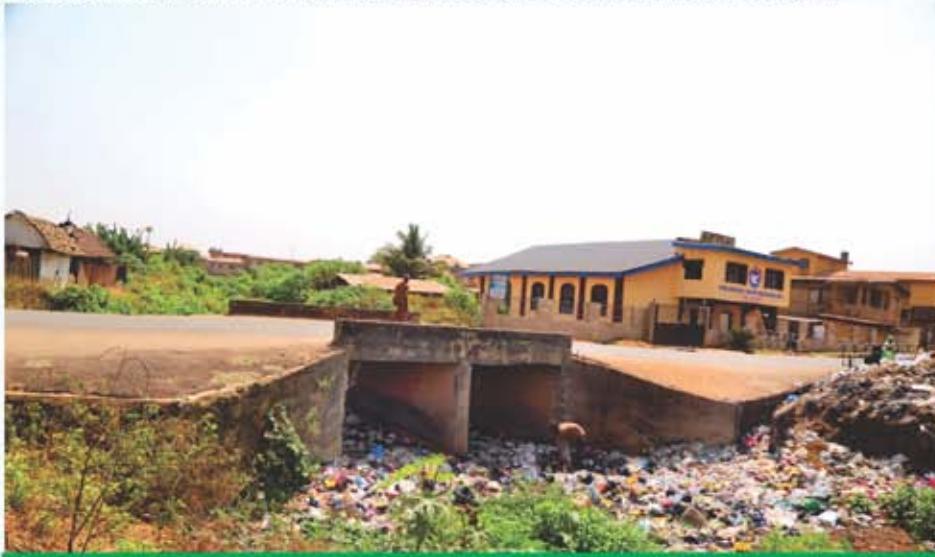
Baseline State of Orogun Culvert by GOFAMINT Church pre-intervention

xi. **ID No 633:** The existing culvert across the Orogun River at the GOFAMINT Church area is being replaced with a **3(6.0 x 2.0)m culvert** in order to ensure that the increased runoff from the channelized river would have a smooth flow.

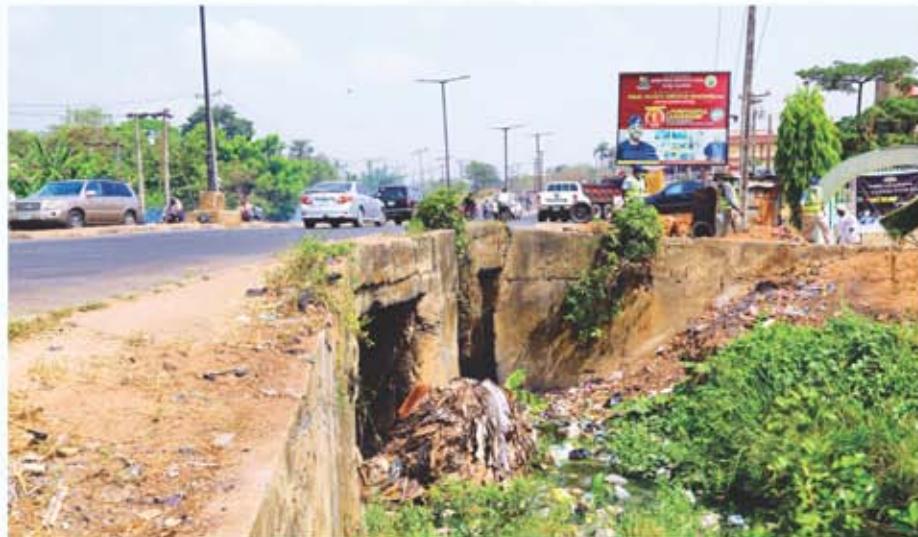
xii. **ID No 122B:** This culvert that spans the UI – Ojoo Highway on the Orogun River is presently hydraulically inadequate and in disrepair, causing backflow of the river runoff. In anticipation of the channelization of the Orogun River, the culvert will be replaced with a **5(6.0 x 2.0)m culvert**.

Baseline State of the Culvert on Orogun River along UI - Ojoo Road pre-intervention

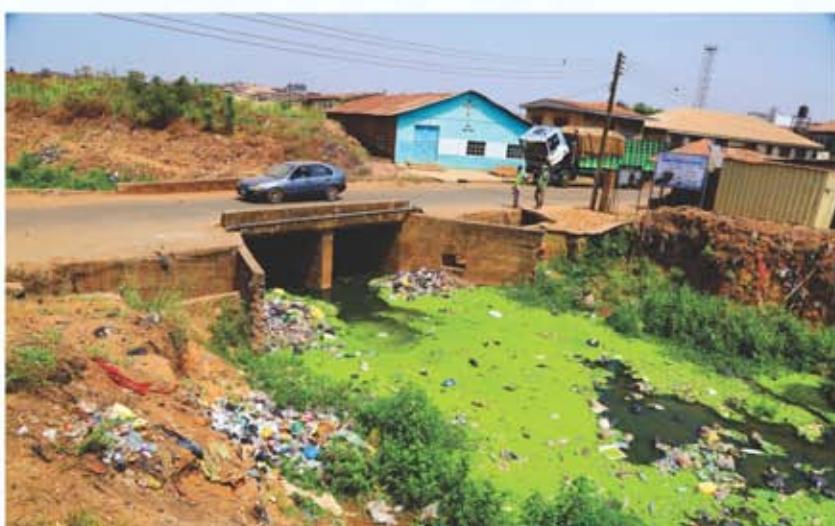
Baseline State of the Culvert on Ogbere River at Akinwumi Street pre-intervention

xiii. **ID No G5:** The existing 2-cell Box Culvert spans the Ogbere River at the Akinwumi/Odewenwa Street axis near Iwo Road Interchange. With the ongoing channelization of the river, the culvert will become too low and inadequate for the discharge/volume of runoff from downstream; hence its proposed replacement with a **2(6.0 x 2.5)m culvert**.

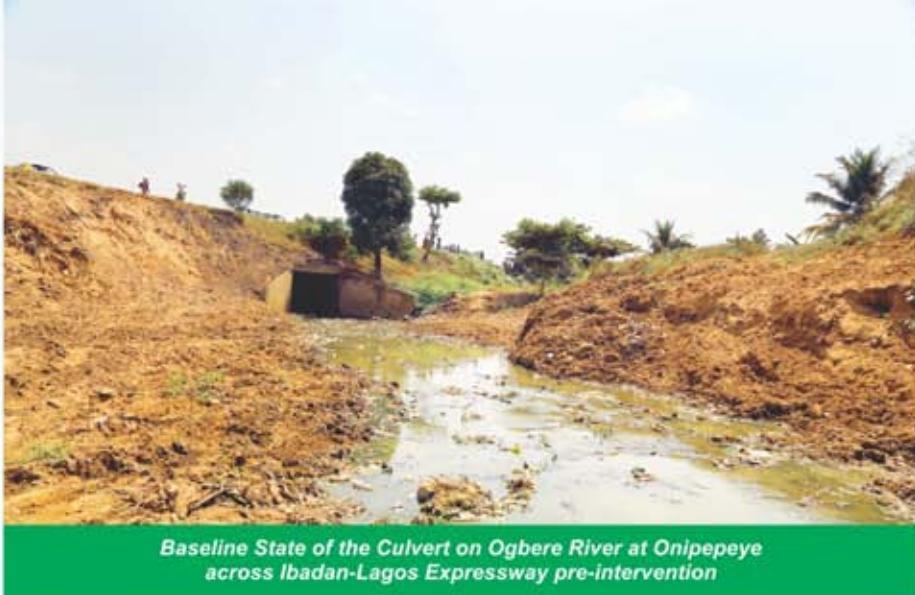
Baseline State of the Culvert on Ogbere River at Onipepeye across Ibadan-Lagos Expressway pre-intervention

xiv. **ID No 86:** This hydraulic device is further down on the Ogbere River channel at the Onipepeye axis, crisscrossing the Ibadan – Lagos Expressway. The single cell culvert, though structurally okay, will become hydraulically inadequate for the channelized river; which is why it will be complemented with a **2(6.0 x 2.5)m culvert.**

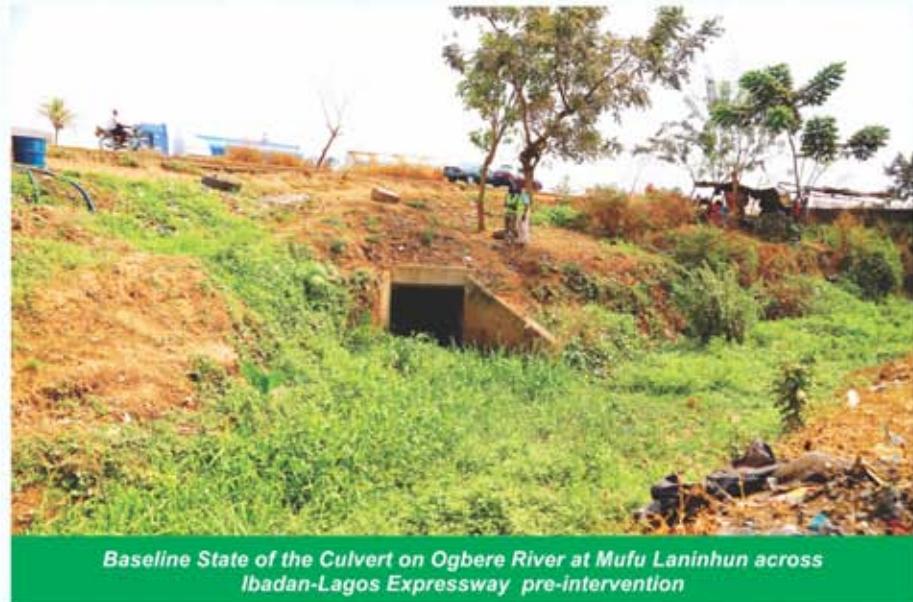
Baseline State of the Culvert on Ogbere River at Mufu Laninhun across Ibadan-Lagos Expressway pre-intervention

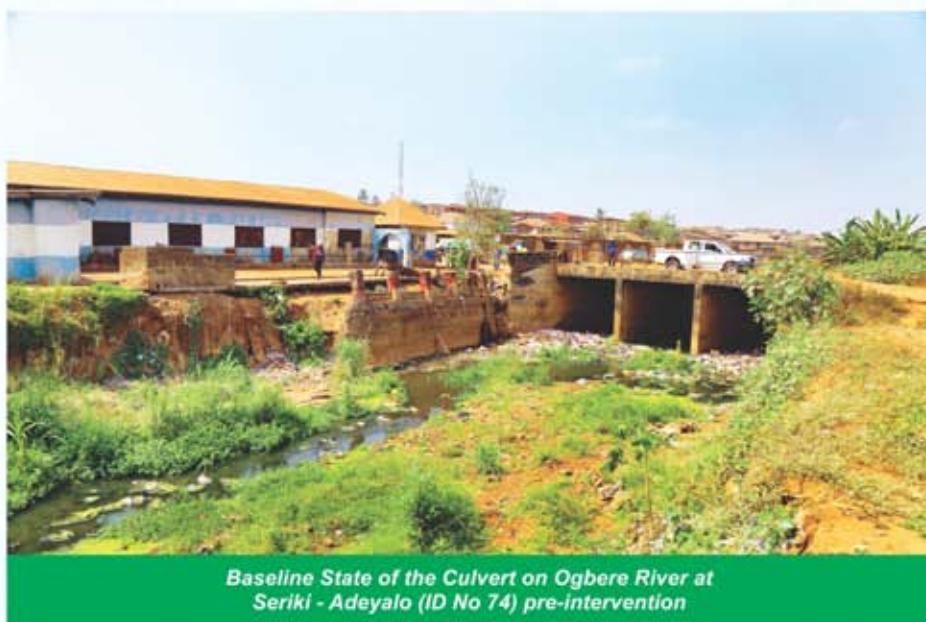
Baseline State of the Culvert on Ogbere River at Seriki - Adeyalo (ID No 74) pre-intervention

xvi. **ID No 74:** This is a 3-cell culvert on the Ogbere River linking the Seriki / Adeyalo areas of Ibadan. Though structurally adequate, the existing culvert would not be hydraulically adequate for the channelized river when completed. Hence, a single span of **1(4.0 x 3.0)m culvert** is being added to complement the standing structure.

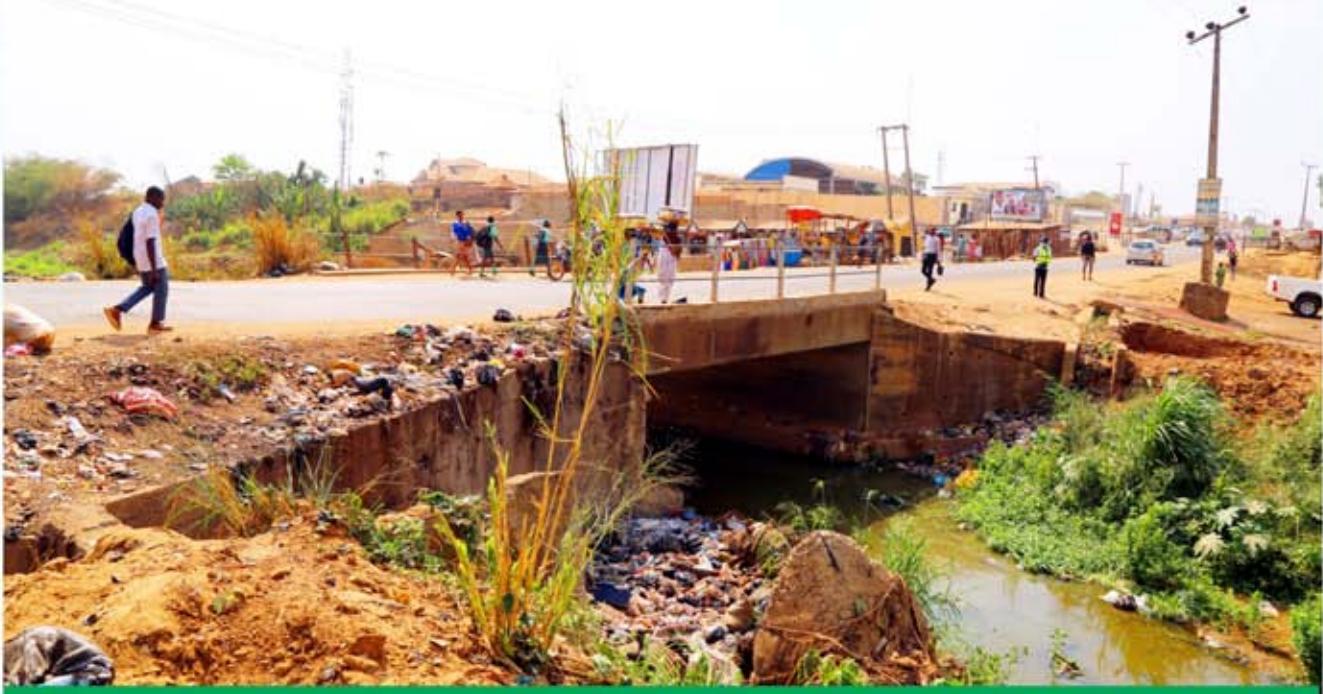
Baseline State of the Ogbere Tioya Culvert pre-intervention

xvii. **ID No 73:** This is the popular **Ogbere Tioya Culvert** on the Olorunsogo – Amuloko – Akanran Road. Being downstream of the river, the flow of the Ogbere River here is known to be heavy and torrential, which results in over-flooding and cutting off of human/vehicular movement. The existing structure is to be replaced with a **4(6.0 x 3.0)m culvert**.

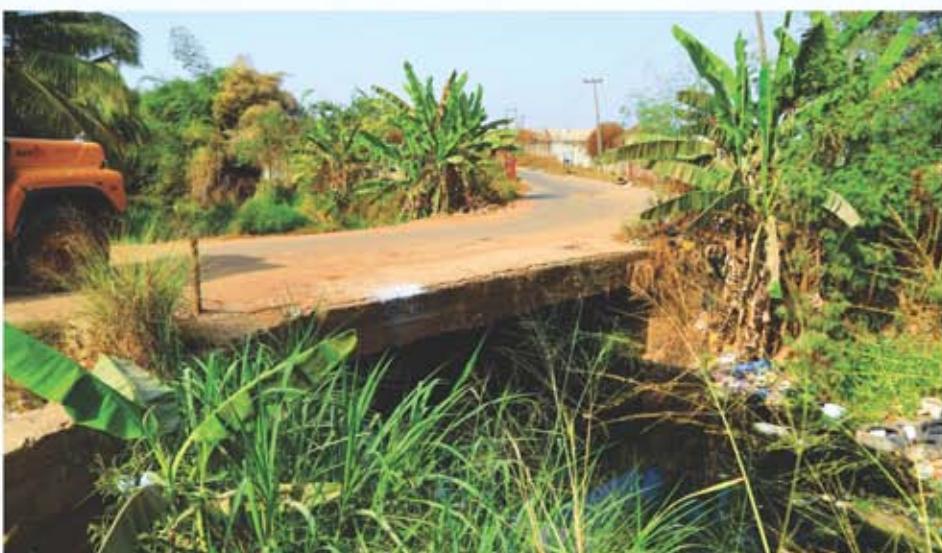
Baseline State of the Oorelope Culvert at Oluyole Zartech Area pre-intervention

xviii. **ID No 23:** This culvert connects the Oorelope Community of Oluyole Estate in Ibadan. In its pre-intervention state, the culvert is too low, causing it to easily get overtopped during heavy rainfalls, resulting in the community being cut off from the rest of the city. It is being replaced with a **8(6 x 2.25)m culvert**.

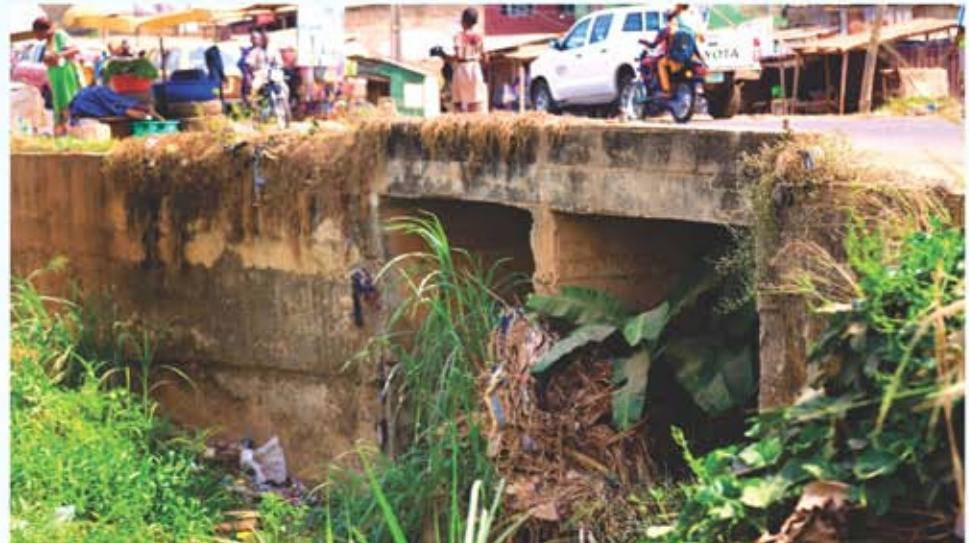
xix. **ID No 76:** This is the culvert on Ariyo River along Olorunsogo–Amuloko –Akanran Road. The size of the culvert has become inadequate for the discharge/volume of runoff in the catchment area; so it is being replaced with a **6(6 x 2.5)m culvert.**

Baseline State of the Olorunsogo - Amuloko-Akanran Road Culvert (pre-intervention)

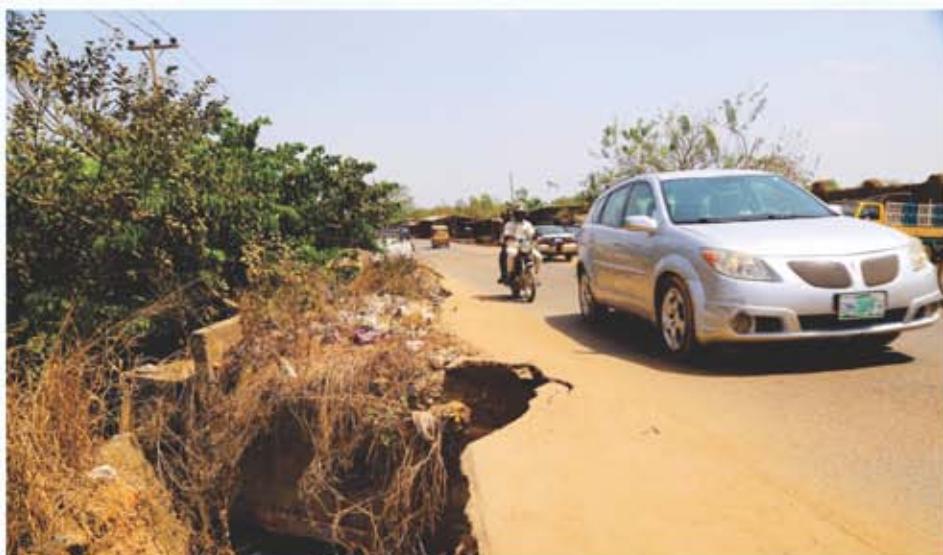
Baseline State of the Culvert at Jerusalem Area, Arulogun - Ojoo Road pre-intervention

xx. **ID No 125A:** This culvert is at the Jerusalem Area along Ojoo – Arulogun Road, Akinyele LGA. The 2-cell pipe culvert is in disrepair, with evidence of failed portions. It will be replaced with a **2(6 x 2.0)m culvert.**

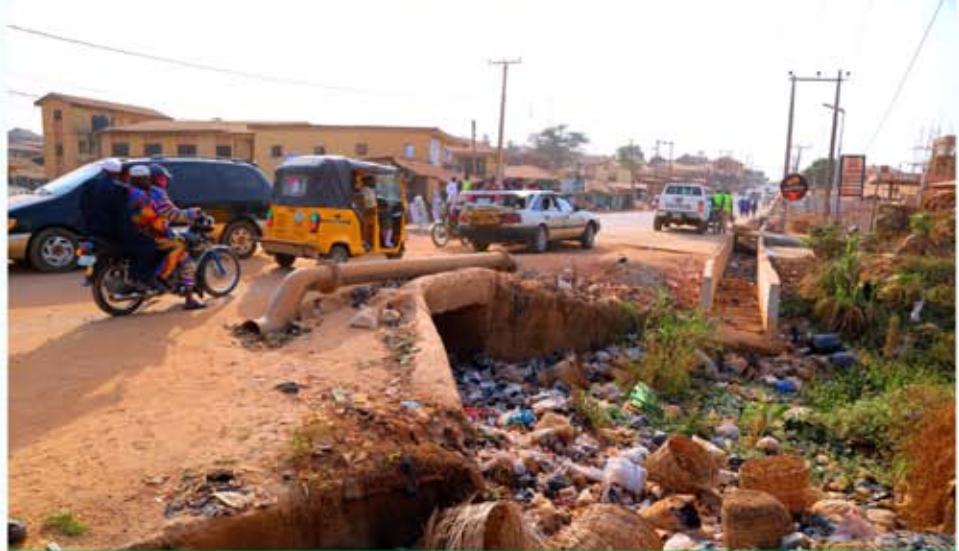
xxi. **ID No 132:** This is the culvert on Abepe Stream along Apete – Awotan Road, Ibadan. It is evidently too low and the headroom is inadequate to channel the runoff from the river course during heavy downpours. It is being replaced with a **1(4 x 2)m culvert.**

Baseline State of the Apete - Awotan - Akufo Road Area Culvert (pre-intervention)

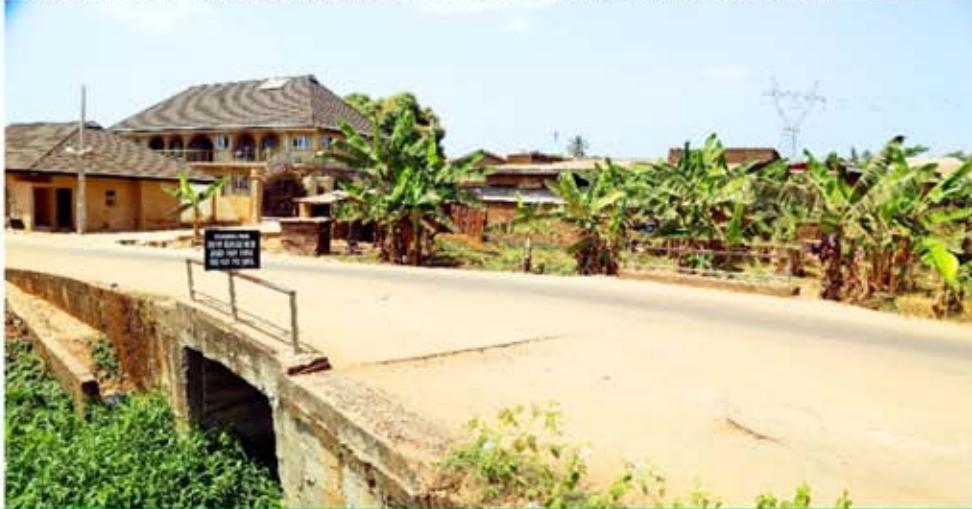
Baseline State of Odogbo Fatokun Culvert, Moniya pre-intervention

xxii. **ID No 195:** This culvert situates at the Odogbo Fatokun area of Moniya in Akinyele LGA. Though the device is structurally adequate consequent on a recent intervention, its inlet and outlet are inadequate, resulting in the areas being heavily flooded during high precipitation. In its place, a **1(3.5 x 1.5)m culvert** is to be constructed.

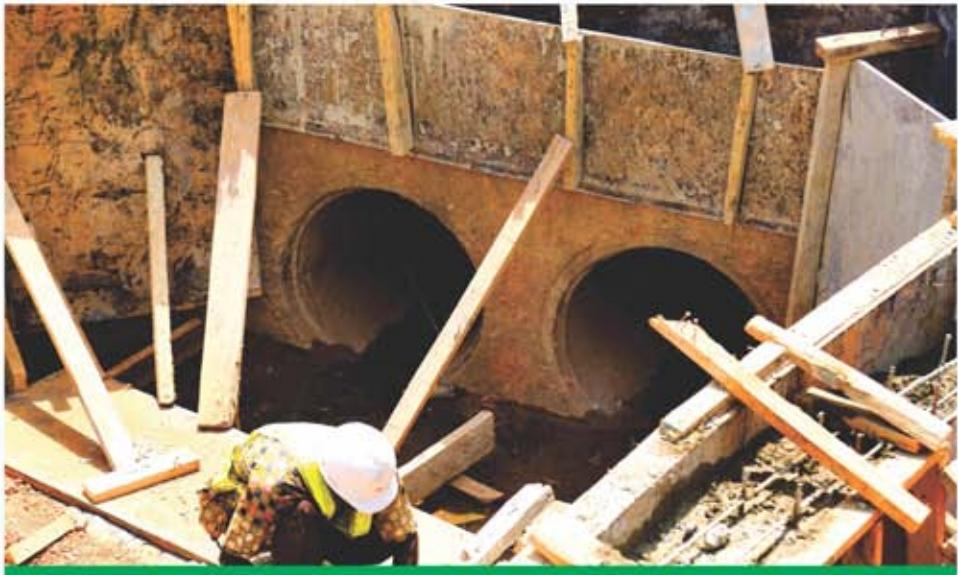
xxiii. **ID No 27T:** The existing structure is a 2-cell Pipe Culvert across the Ibadan – Ife Expressway close to the Iwo Road Interchange. It has become visibly inadequate, thus causing backflow upstream which results in flooding and waterlogging of the surroundings of both the inlet and the outlet. In lieu, a **(3.0 x 2.0)m culvert** is being constructed.

Baseline State of Iwo Road Interchange Culvert along Ibadan-Ife Expressway pre-intervention

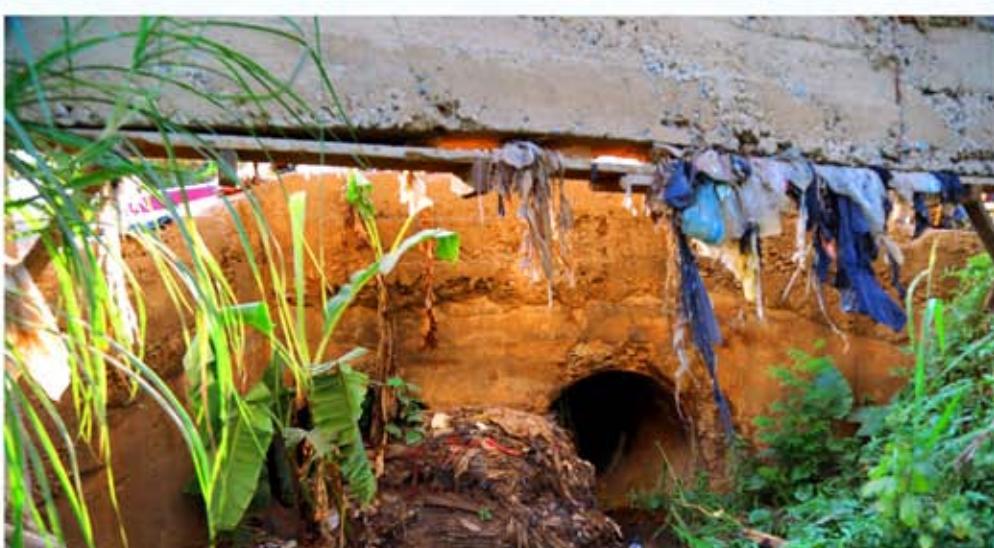
Baseline State of the Inlet of the Ajibode - NISER Area Culvert (pre-intervention)

xxvi. **ID No 6T:** This is a 2-cell pipe culvert on Ajibode Road, NISER area, Ibadan. The rings have evidently become too narrow to channel runoff from upstream across the road to the downstream, which often resulted in overflooding in the area. The aged culvert is being replaced with a **1(4 x 2)m culvert**.
